► **Reporting for Part 3 of the Norwegian Environment Agency's orders: "Overall assessment of PFAS contamination at Avinor's airports"**

Assessment of local impacts

Assignment no.: 5185352 Document no.: Environment-03 Version: J02 Date: 29 August 2019

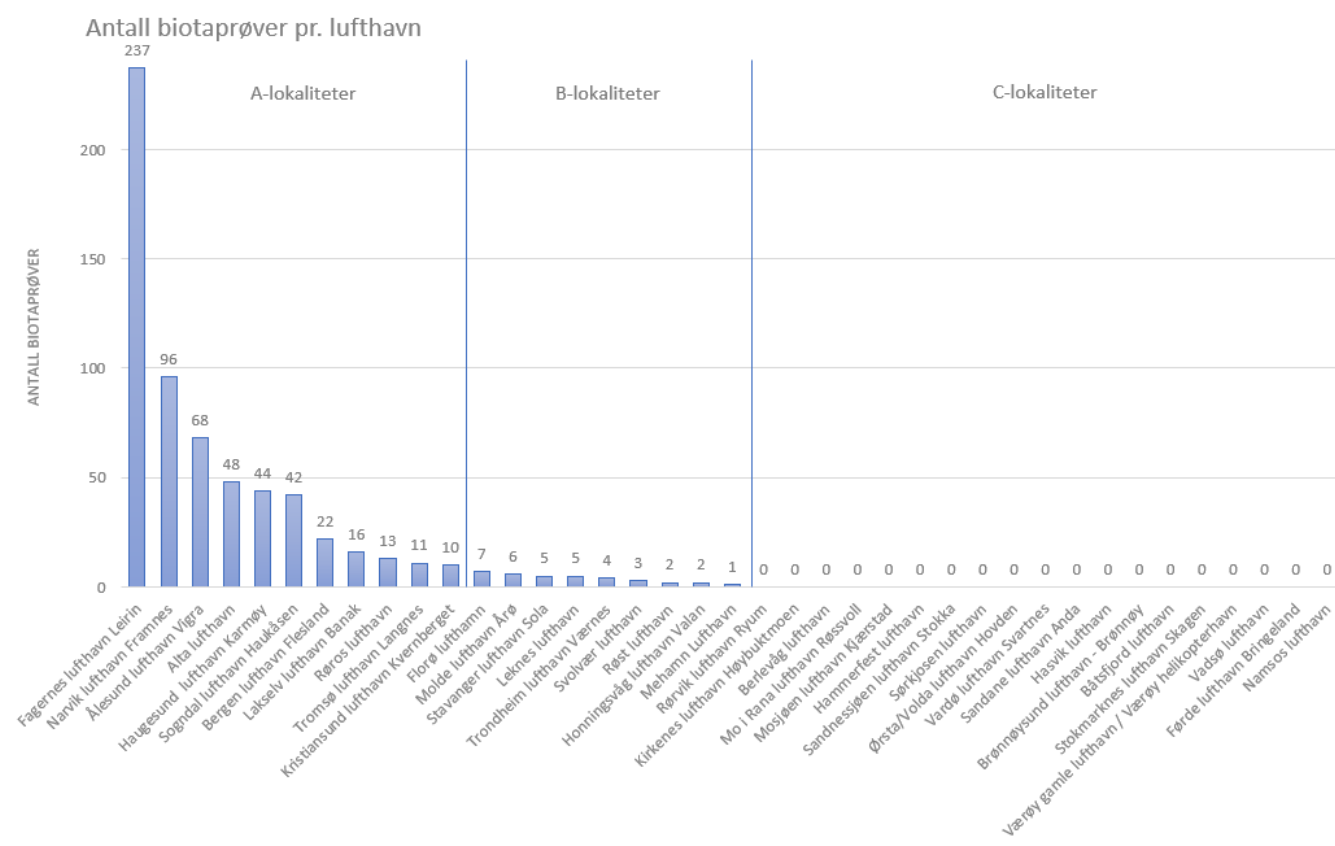
Figure 1. Number of analysed biota samples at all airports covered by the orders, irrespective of species and matrix.

Categories	Descriptions
A airport	> 10 biota samples analysed
B airport	≤ 10 biota samples analysed
C airport	No samples taken/analysed

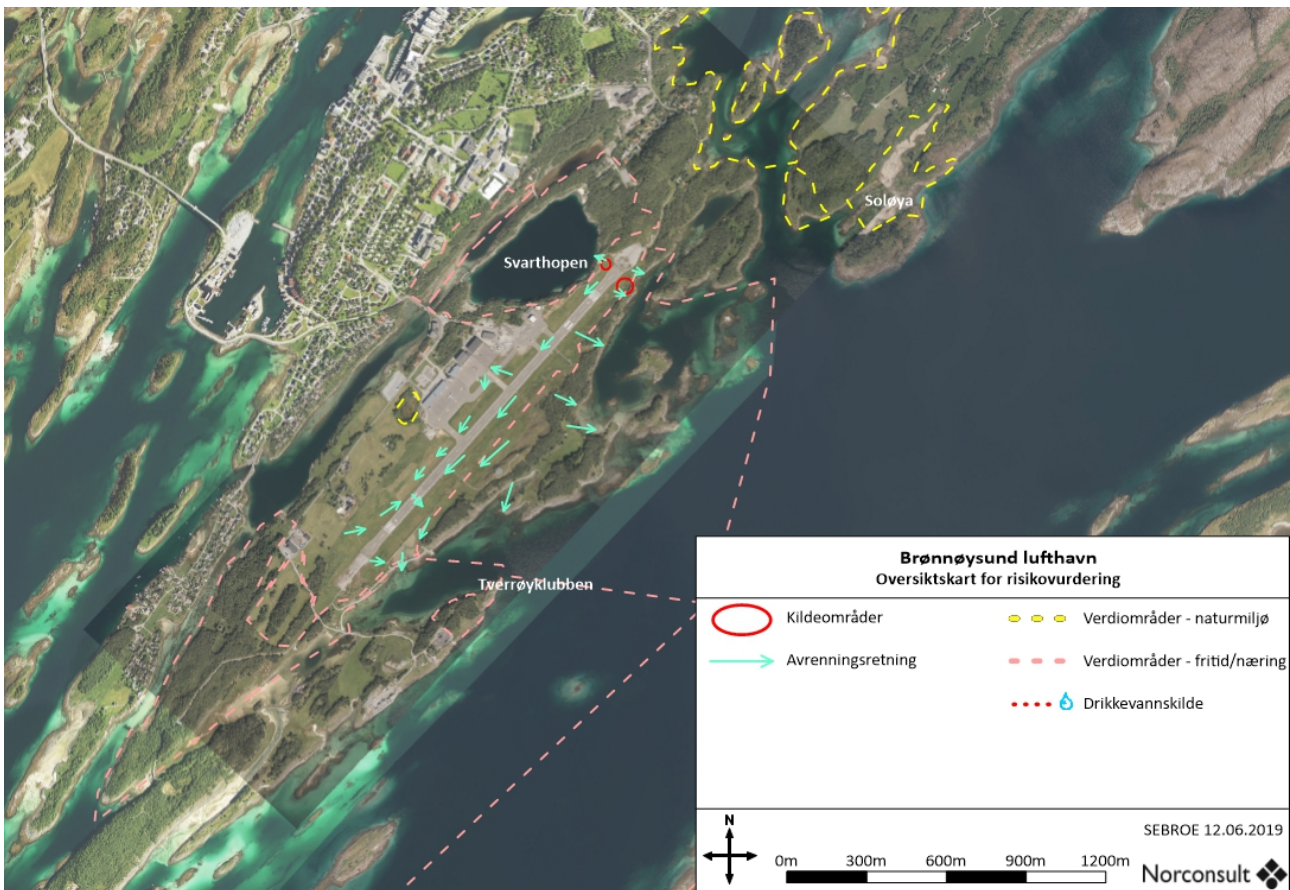
Figure 23. Brønnøysund Airport, Brønnøy. Thematic map of local risk.

No samples have been taken from the actual fire training site itself because the runway has been extended over the area previously used as the fire training site. There is therefore some uncertainty surrounding the degree of contamination of the materials in the old fire training site. Water samples taken downstream from the fire training site show that there is some leaching of PFOS to the recipient. PFOS has also been detected in water samples taken at the other end of the runway in relation to the fire training site. This may indicate that firefighting foam has also been used in places at the airport other than the old fire training site.

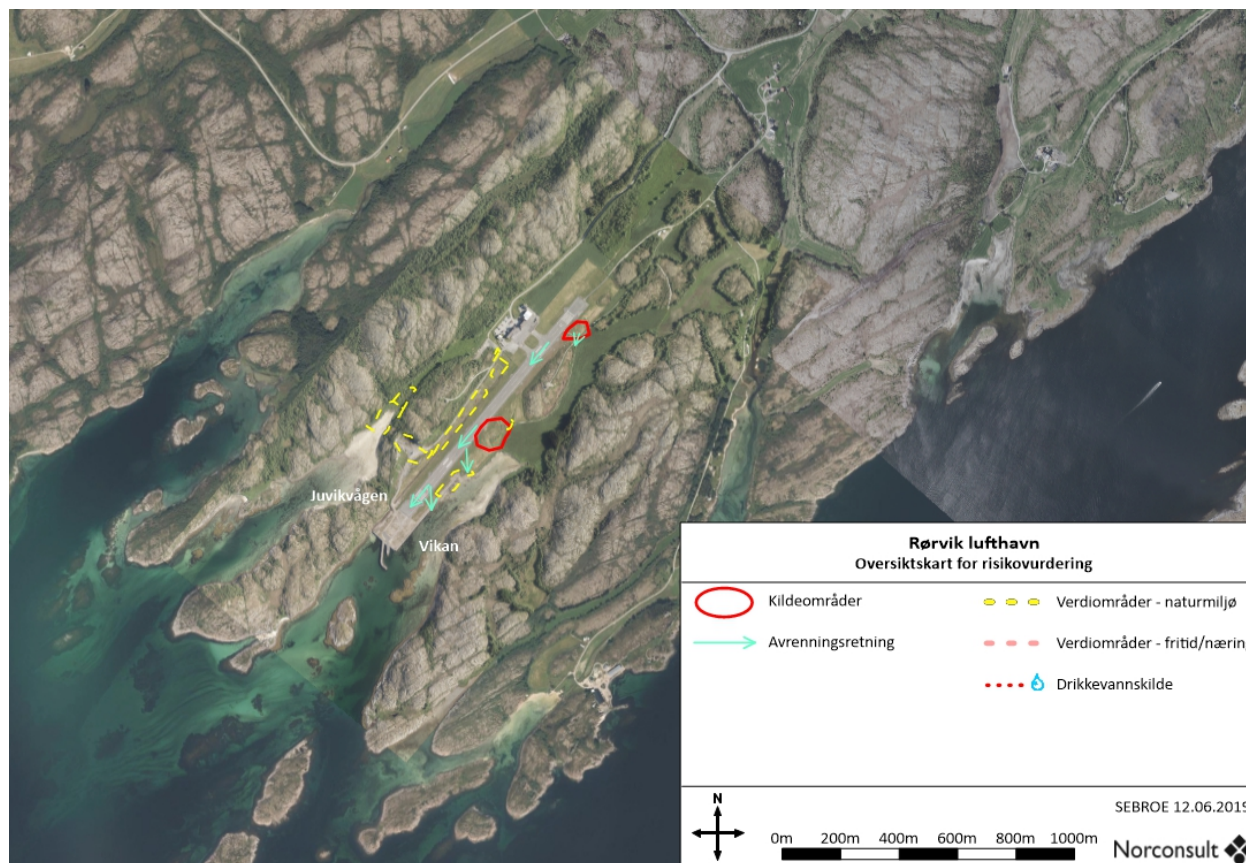
Figure 32. Rørвик Airport, Ryum. Thematic map of local risk.

Very high concentrations of PFOS were detected in some of the soil samples taken in BØF 2. Very high concentrations of PFOS and Σ PFAS were also detected in a groundwater sample taken from shaft BN5 in BØF 2, but this may be due to a lot of particles in the water, as well as PFOS being mobilised by excavation below groundwater level. Therefore, this groundwater sample may not be representative of the contamination situation in the groundwater in the area. Rørвик is the airport with the highest total annual volume of dispersion (912 g/year) among the surveyed airports covered by the orders.

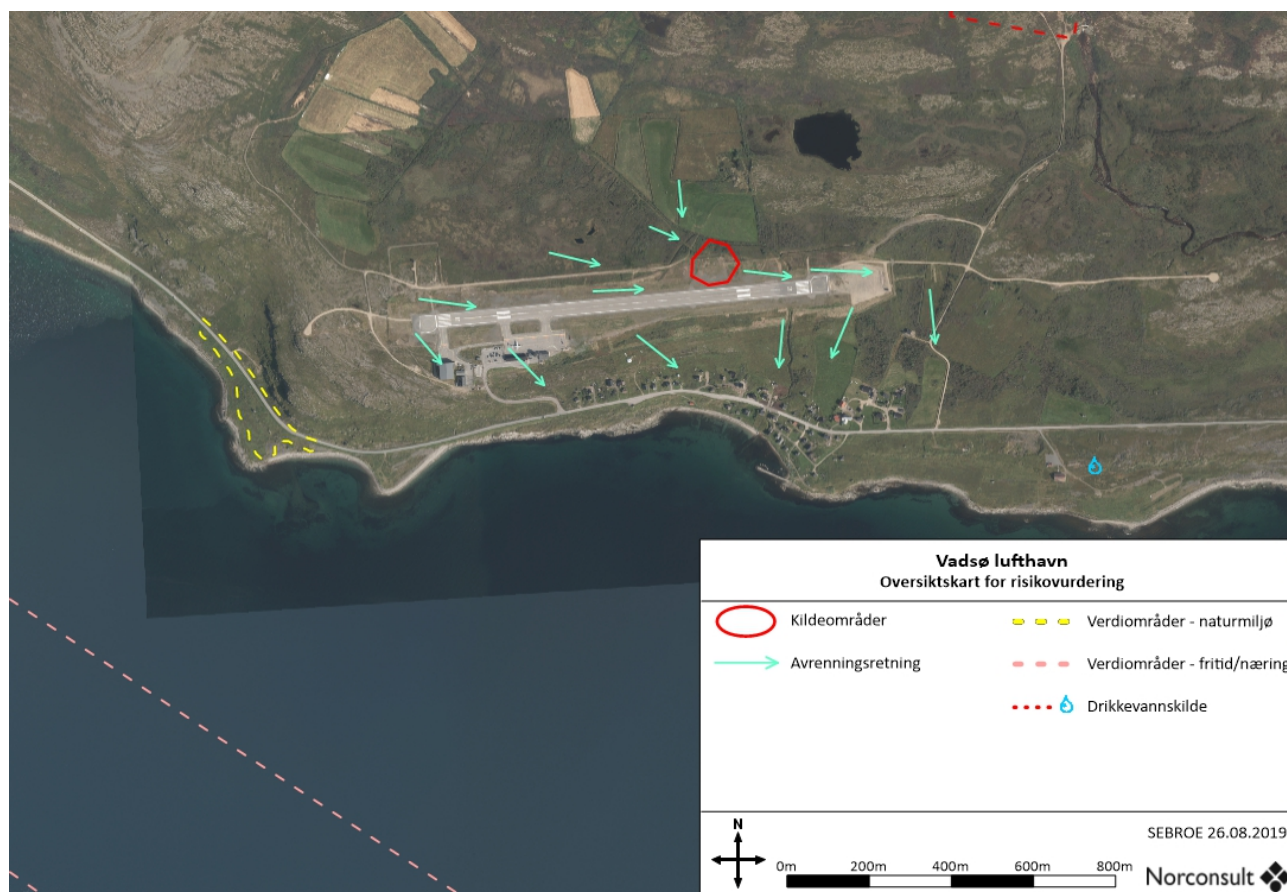
Figure 37. Vadsø Airport. Thematic map of local risk.

The unconsolidated materials in the area consist of marine deposits and sand. Few samples of the deeper lying materials have therefore be taken in BØF 1 and there is thus some uncertainty surrounding the degree of contamination here.

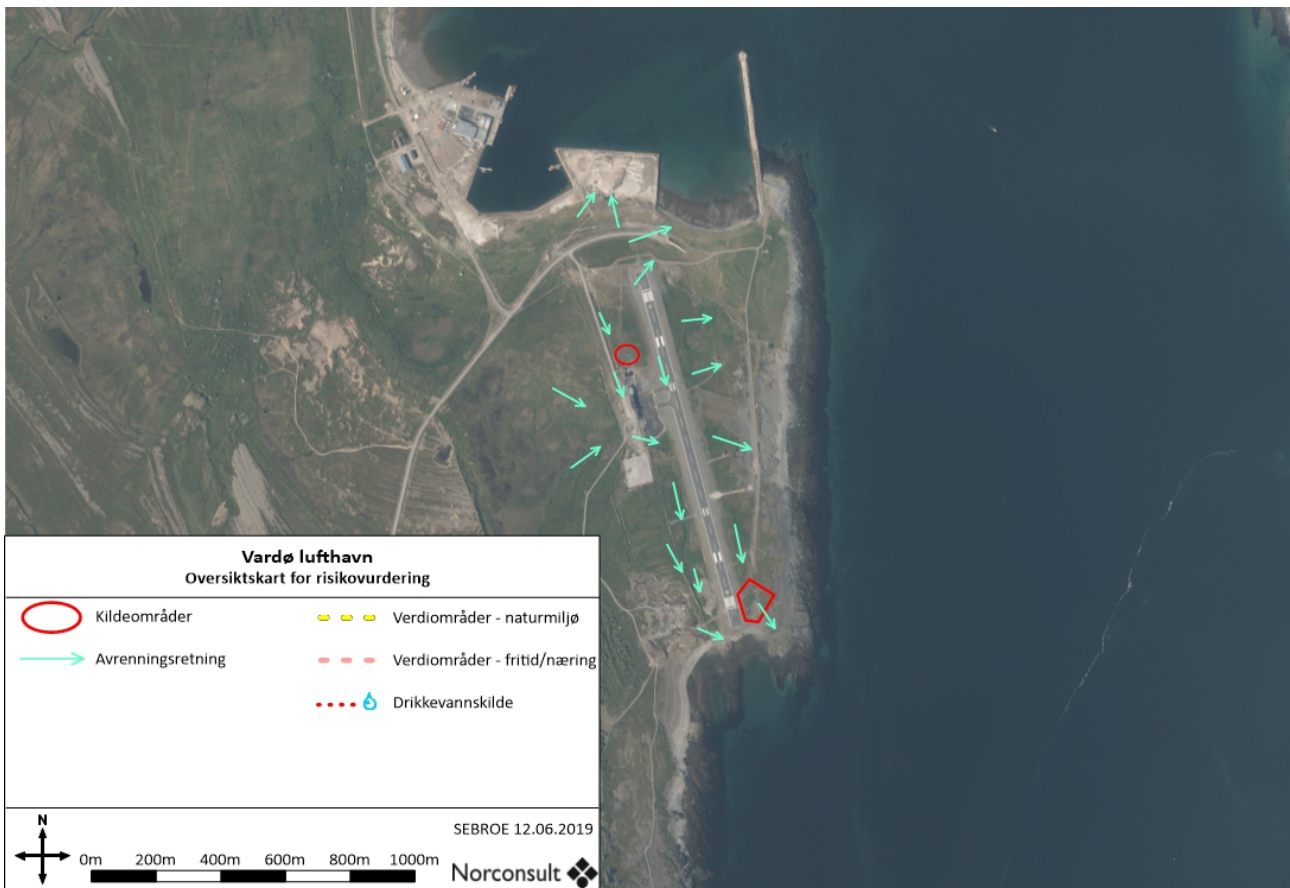
Figure 38. Vardø Airport, Svartnes. Thematic map of local risk.

High concentrations of PFOS were detected in water samples taken in BØF 2. This does not fit very well with the relatively low concentrations of PFOS in the groundwater. There is some uncertainty surrounding the exact location of the two fire training sites and whether the soil samples cover the most central parts of these.
